## Custom Builder

### Tearing Down and Building Anew 10

# Teardown, Salvage, Two custom home projects take on demolition challenges and opportunities to repurpose portions of the original and Design

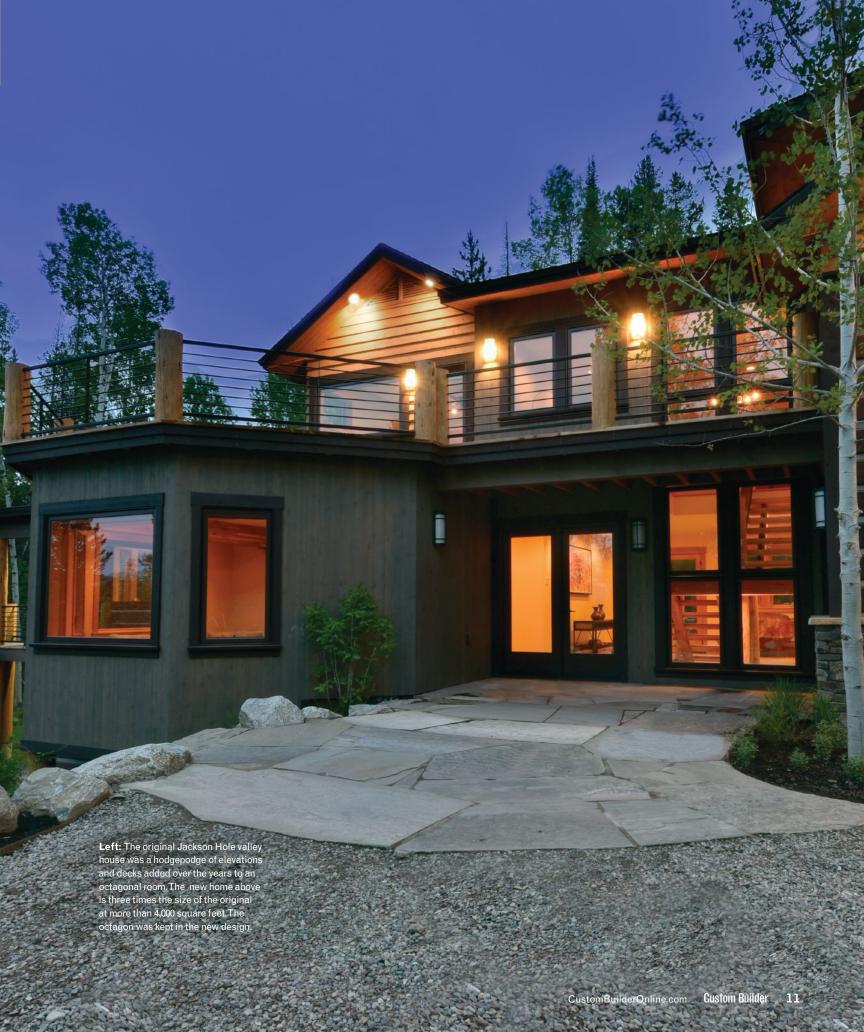
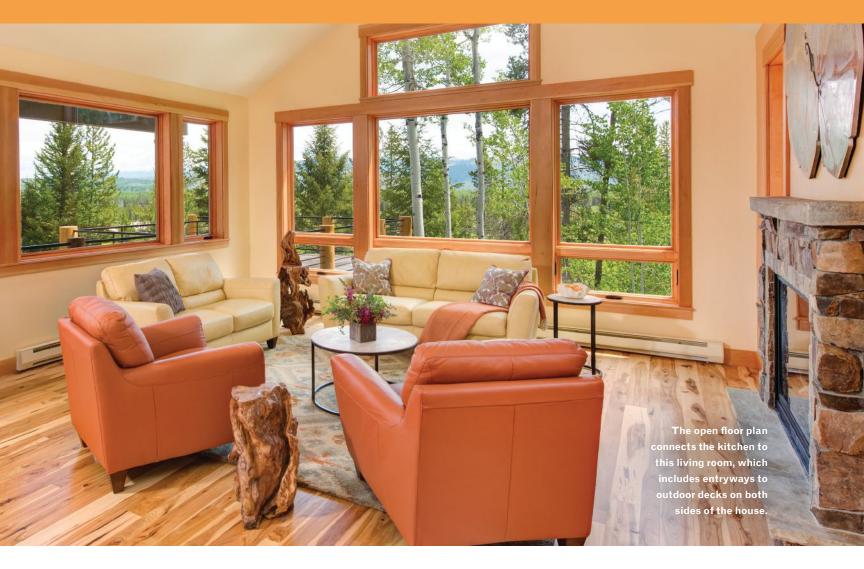
and died within the walls. Later, the crew removed a wood-framed wall built in front of a foundation wall that abutted the hillside. They unveiled an unreinforced concrete block wall that was bulging, lacked mortar, and was on the brink of failing.

Either the handyman owner or a remodeler tried to "fix" the problem by scribing studs against the bulging CMU wall and attaching joist hangers to the studs so they wouldn't kick out from the bottom plate due to the lateral pressure of the hillside. The main building was literally draped over that wall; it and another lateral shear wall were the only supports holding up the house. Given that the valley is in the same seismic zone as Los Angeles County, in addition to weathering wind gusts and at least four feet of annual snowfall, "the fact that the house was still standing is amazing," Moulder says. The building was jacked up for about eight weeks while crews worked to excavate the foundation, which was a combination of blocks and hand-mixed concrete. But rain steadily fell during the first two weeks, and the temporary support cribbage started to sink.

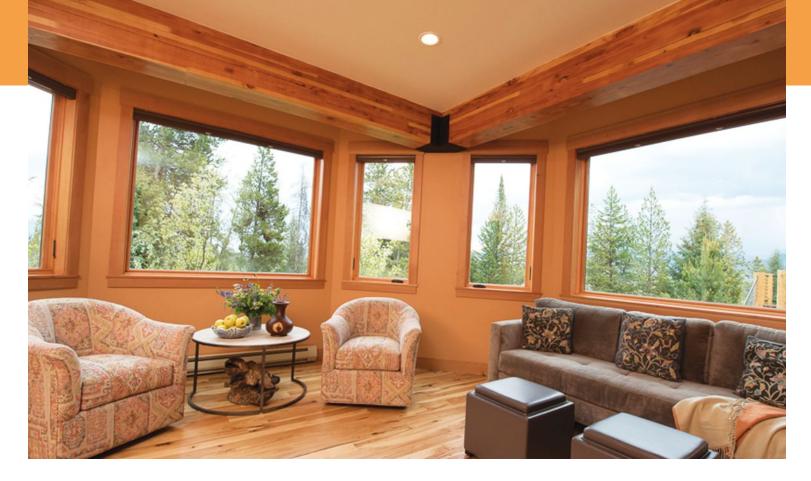
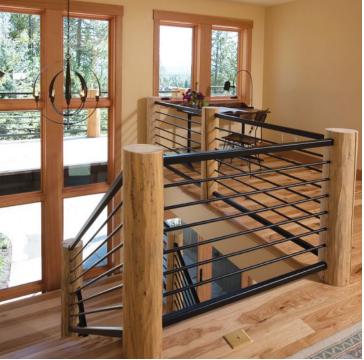
**Top:** The octagon room still includes the original timbers after the ceiling was raised 3 feet and the floor lowered by a foot. The mountain view became the focal point by enlarging the windows in the room and (above) designing windows to daylight the stairway leading to the second floor.

The house was set down and demolished, except for the octagon and a portion of a concrete slab in the basement. Moulder designed a new house that used the existing logs and timbers from the octagon room. However, that part of the home, which now serves as a second bedroom and office, seemed too compressed for a 4,000-square-foot house that is three times larger than the original building. Welker suggested raising the octagon's ceiling by 3 feet, lowering the floor a foot, and adding new walls and bigger windows.

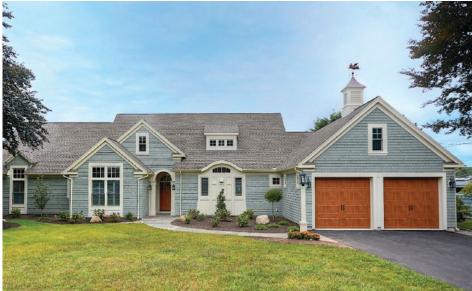
The streetside view shows how venting for the overhead rangehood in the kitchen was subtly designed into the center of the front elevation. "We worked hard to incorporate the hood into the exterior trim, and we have glass all around that. I think it worked very well," says architect Jack Kemper.
